LITHOLOGICAL RESPONSES TO SEA EROSION ALONG THE COASTLINE FROM GOLD
HILL (KOMENDA) TO AMISSANO (SALTPOND)

2012

Thesis submitted to the Department of Geography and Regional Planning of the Faculty of
Social Sciences, University of Cape Coast, in partial fulfilment of the requirements for award of
Master of Philosophy Degree in Geography

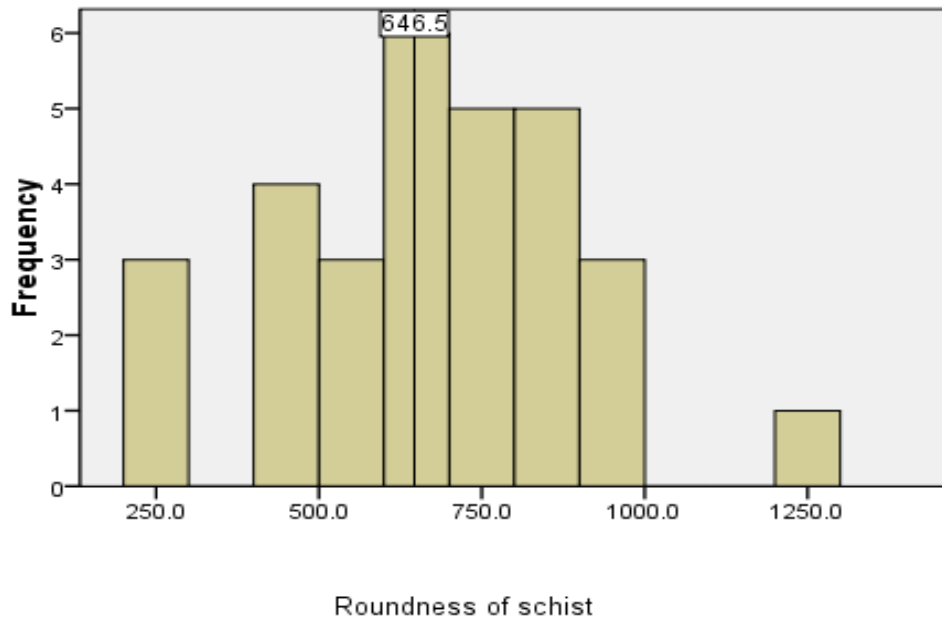
Figure 6: A histogram showing the roundness of schist, Cape Coast

Figure 6 is a trimodal graph showing roundness of schist from Cape Coast with a median value of 646.5. This did not conform to the flatness graph of the same location in Figure 3 which was bimodal. The lone peak with the extreme value represented pebbles that may have come from the same location but different environment with intense abrasion process such as in potholes where pebbles were turned constantly. The peak on the right with the least value represented pebbles collected towards the west, the middle peak showed pebbles picked towards the east and the last peak in the same location but from a pothole. The lone peak with highest value may also represent pebbles that had attained roundness at its apex which will soon undergo fragmentation due to the fissility of schist.

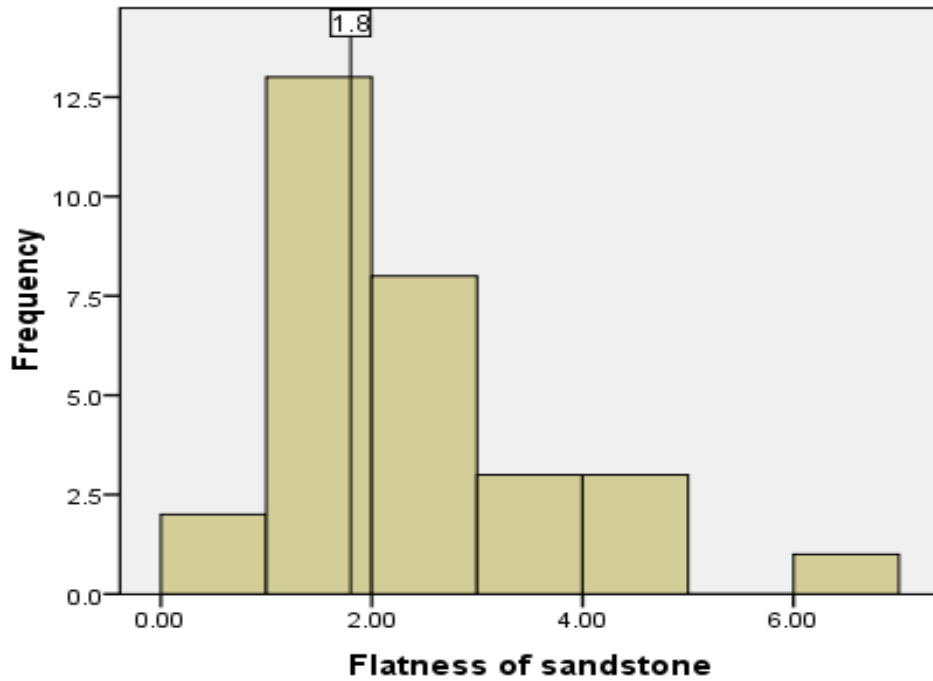
Figure 7: A histogram showing the flatness of Elmina Sandstone

Figure 7 showed that the samples were not from the same location but from two different environments. One location was towards the east while the other was to the west. From the graph, flatness increased towards the west with value as high as 6.8. This was in conformity with the inverse relationship between roundness and flatness as well as the general observation that roundness increased eastwards with increases in fetch distance.

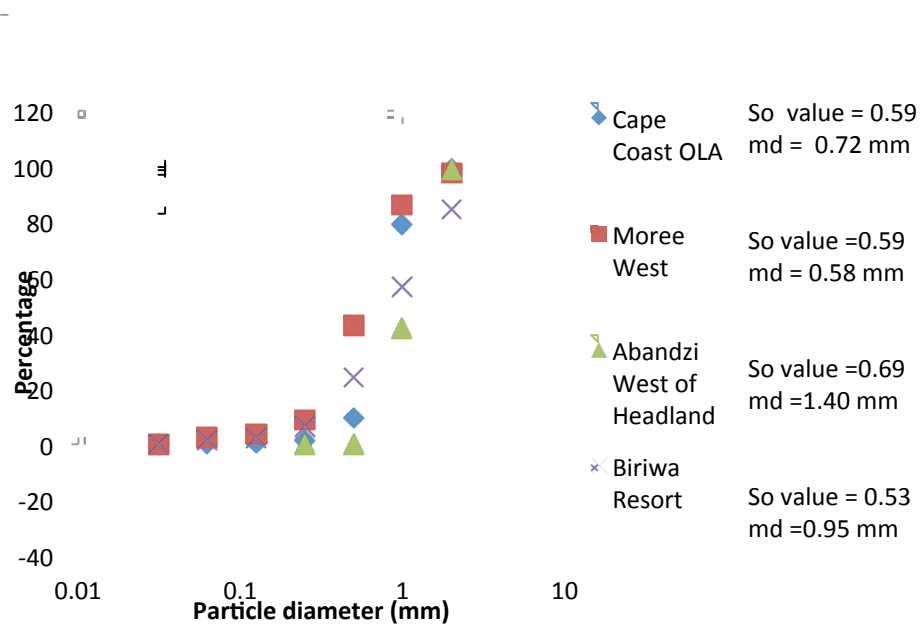
Figure 40: Sorting characteristics of zone B - Rocky coastline with granite intrusions

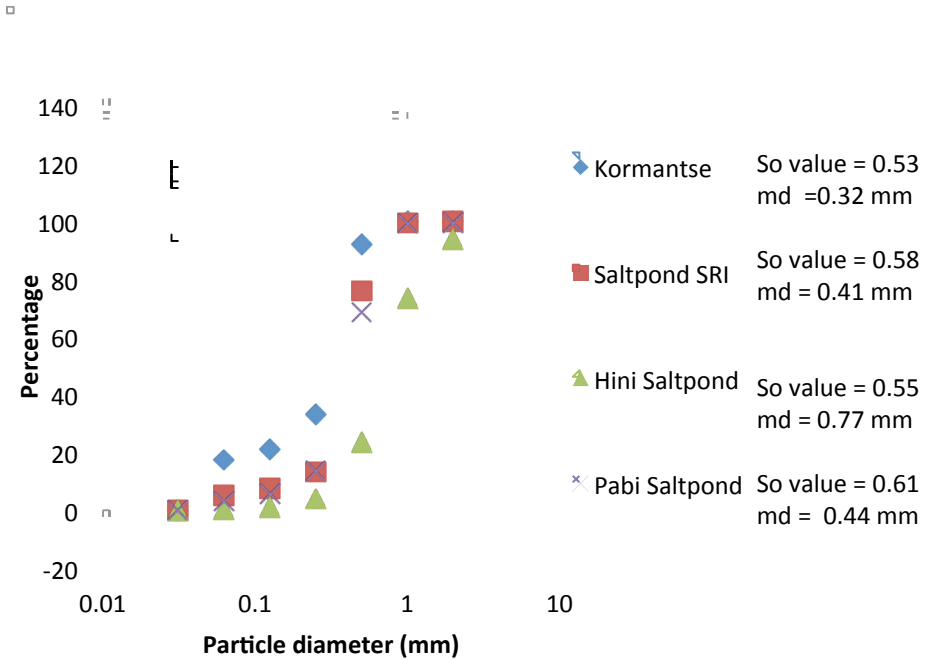
Figure 41: Sorting characteristics of zone C - Sandy beaches

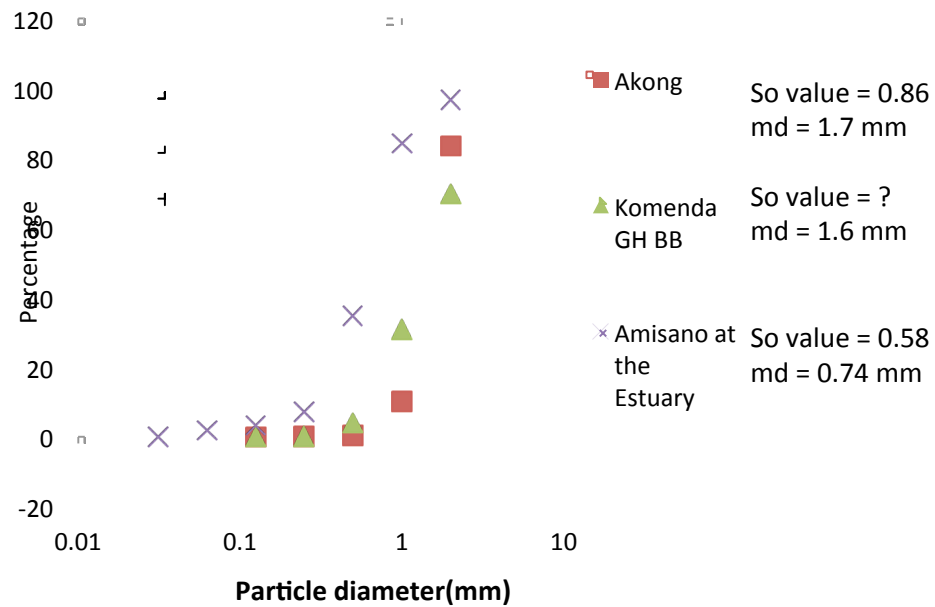
Figure 43: Sorting characteristics of beach samples from all zones

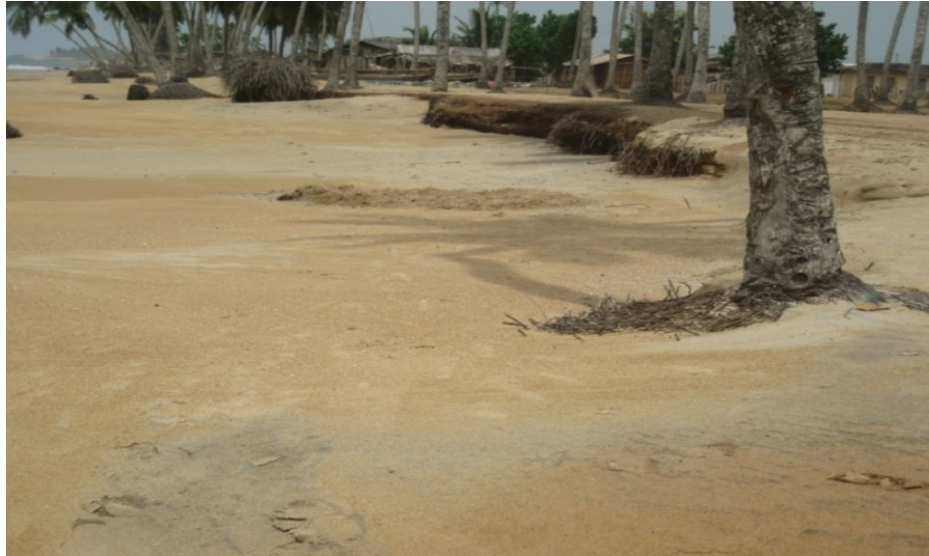
Plate 1: A pictures of eroding cliff face with buildings built close by at Brenu Akyinu. There were stone revetment buried some metres deep on the beach at the resort centre. These revetment were used to check erosion but has been buried as erosion and deposition intensifies (Field Observation, 2008-2011). Some natives had to abandon their homes as the sea advances and this puts economic hardship on the natives.

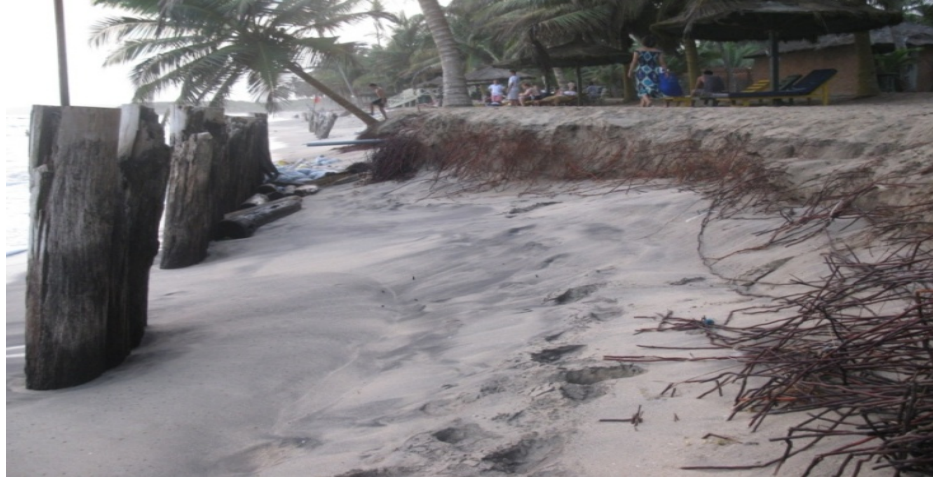
Plate 2: A picture of eroding soft cliff at Anomabo Beach Resort (Field Observation, 2008-2011). Some facilities such as summer huts and other structures are washed away as erosion continues on the beach.

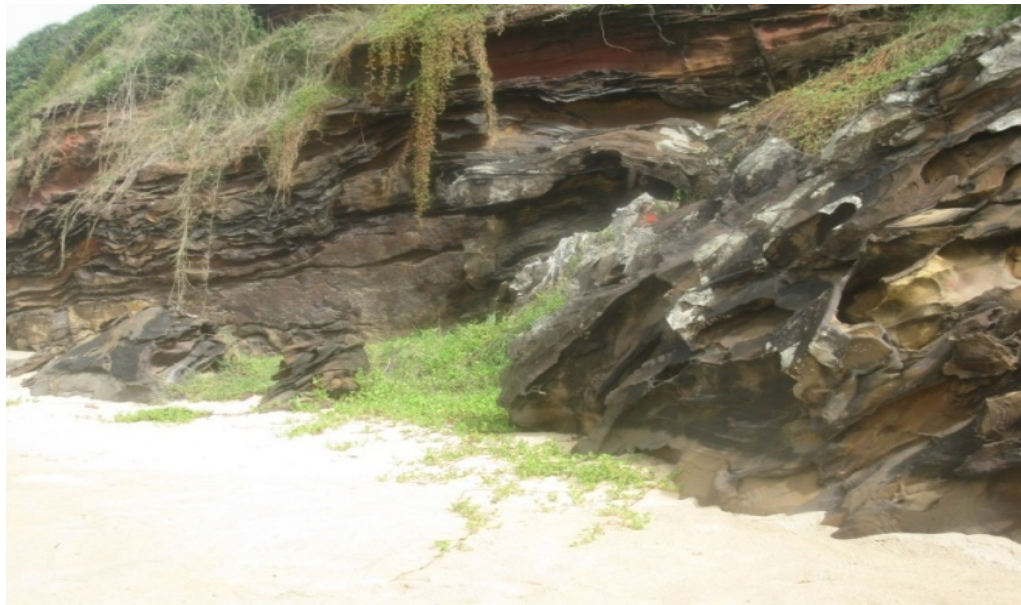
Plate 3: Outcrops of Takoradi sandstone which is friable, massive and embedded with shaly sandstone at the beach at Komenda. The rocks show concentric ferruginous bandings on the limonitised surface (Field Observation, 2008-2010).

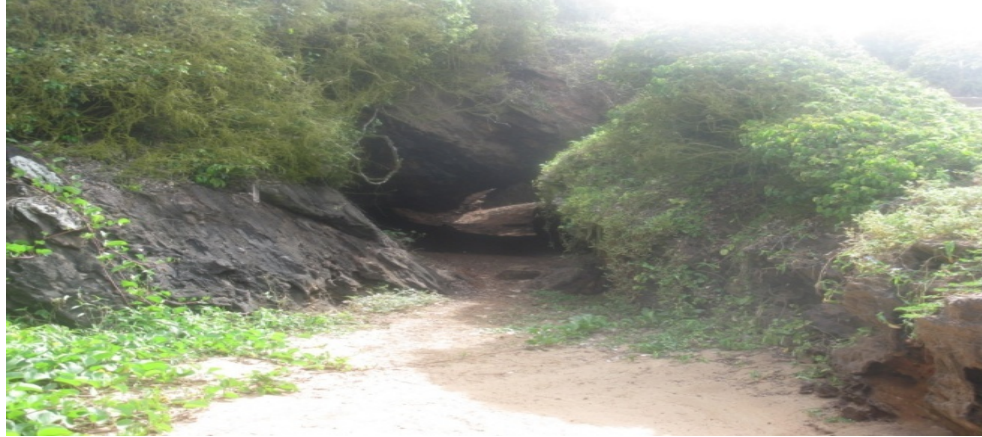
Plate 4: A natural cave entrance at Gold Hill, Komenda. This leads to a gloup which is overgrown with weeds about 10m from the cave entrance (Field Observation, 2008-2010).

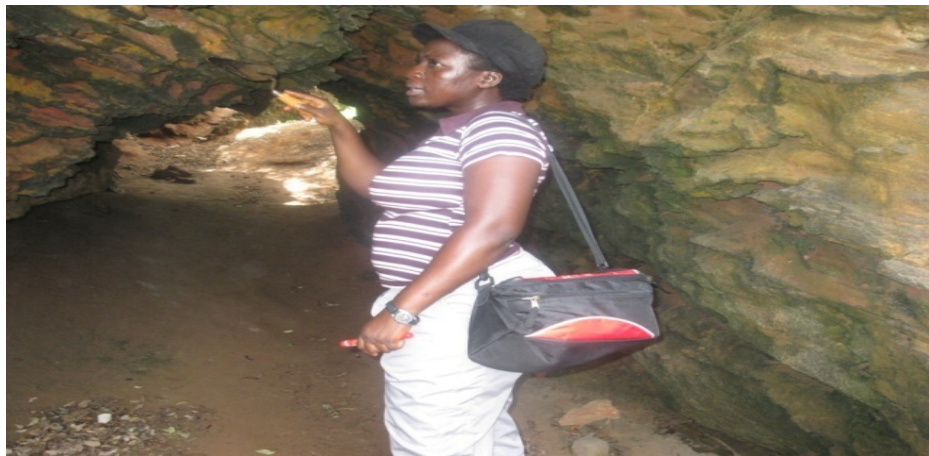
Plate 5: A natural cave at the beach at Gold Hill, Komenda (Field Observation, 2008-2011).

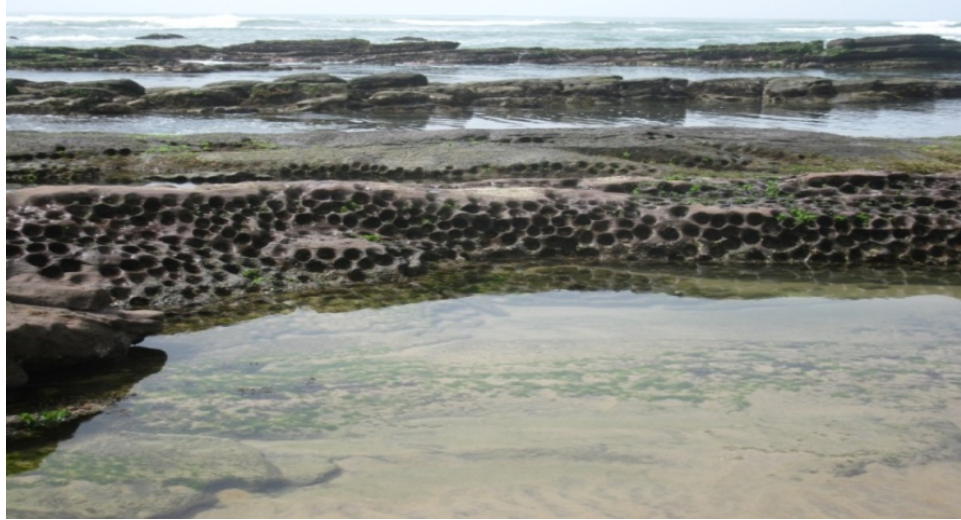
Plate 6: Circular holes, polygonal patterns and long channels on the feldspathic sandstone outcrops at Komenda, Elmina and Iture. These structures were also found in the granitic outcrops at Anomabo (Field Observation, 2008-2011).

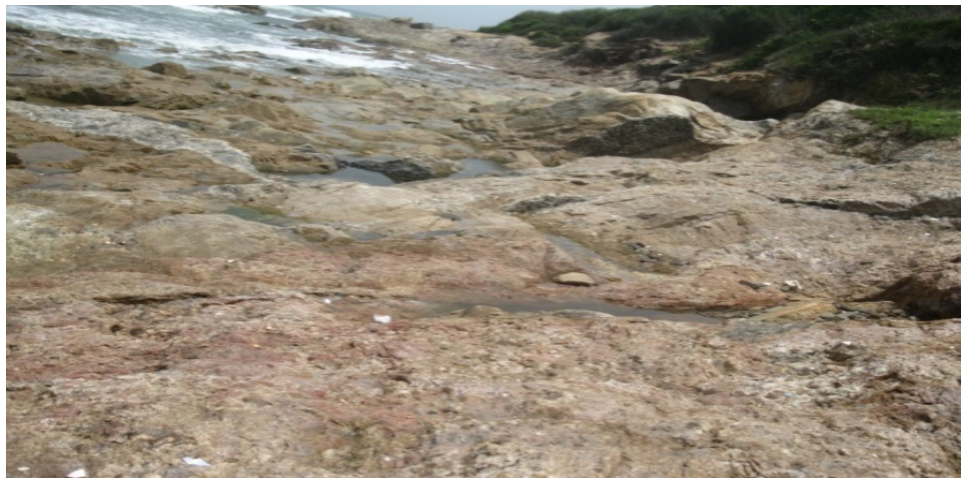
Plate 7: Outcrops of granites, pegmatites and metamorphosed schists between Cape Coast and Akong (Amoanakofoa). There were also rounded and semi-rounded pebble and this could have resulted from the collapse of the roofs of caves and the fragments subject to some amount of erosion (Field Observation, 2008-2011).

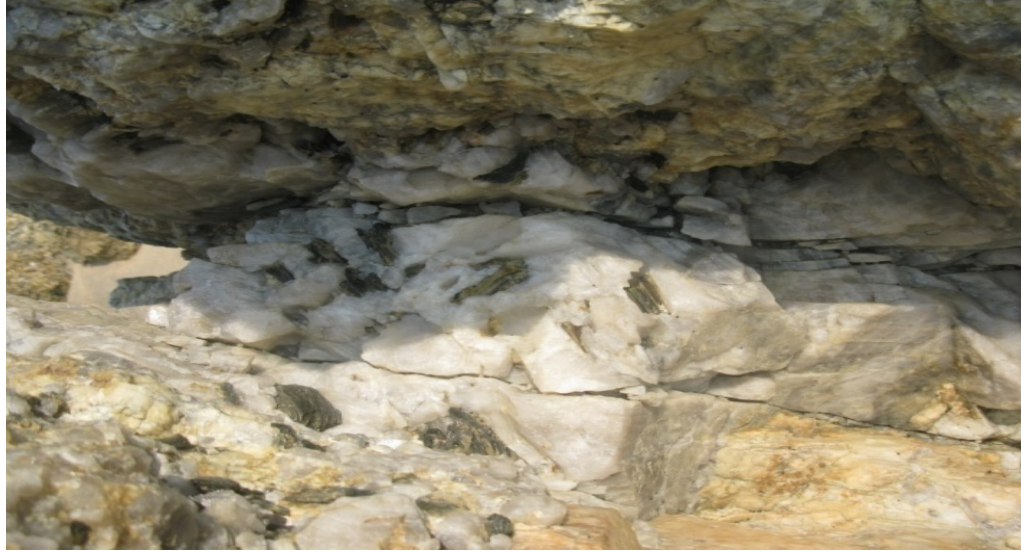
Plate 8: Course grained pegmatite and quartz on the beach at Anomabo near the Anomabo Resort. (Field Observation, 2008-2011).

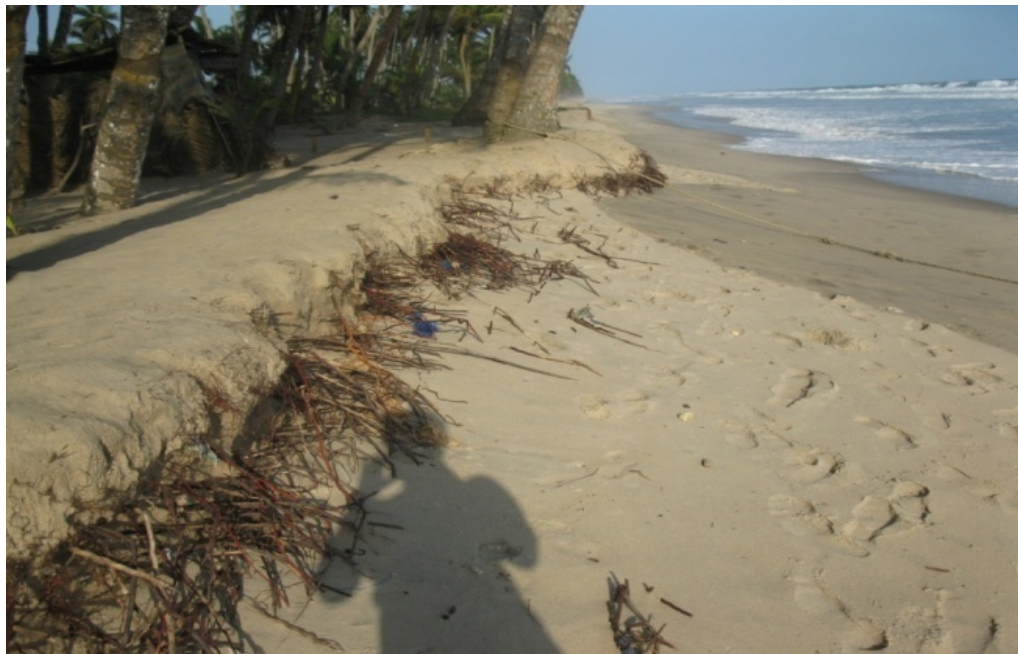
Plate 9: Eroding sandy beach found in zone C between Saltpond and Kormantse. Retreating sandy cliffs are common in this area with excavated coconut roots. This could easily be observed in the picture above (Field Observation, 2008-2011)

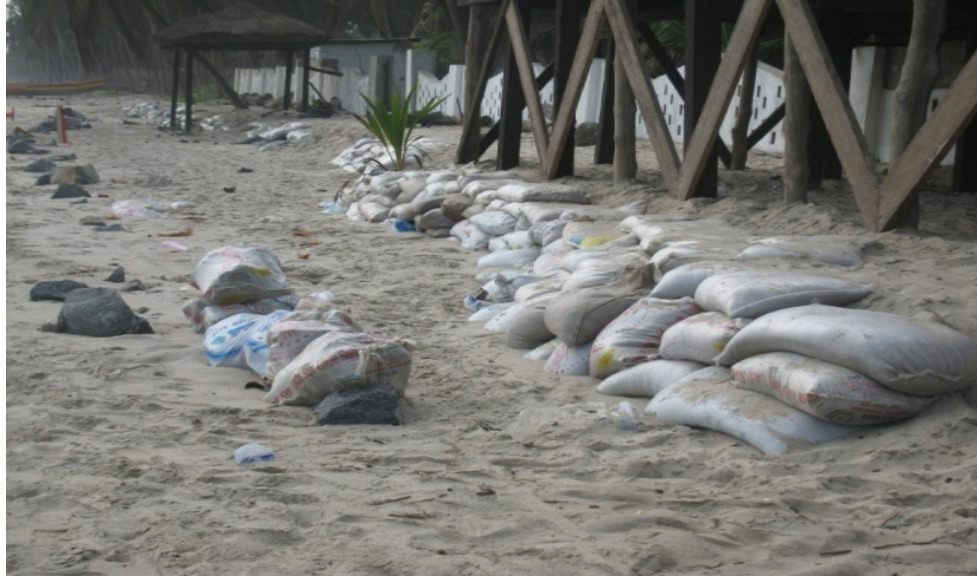
Plate 10: shows efforts being made by natives to prevent further erosion. However these efforts have been proved futile since the structures are being eroded and buried on the beach (Field Observation, 2008-2011).

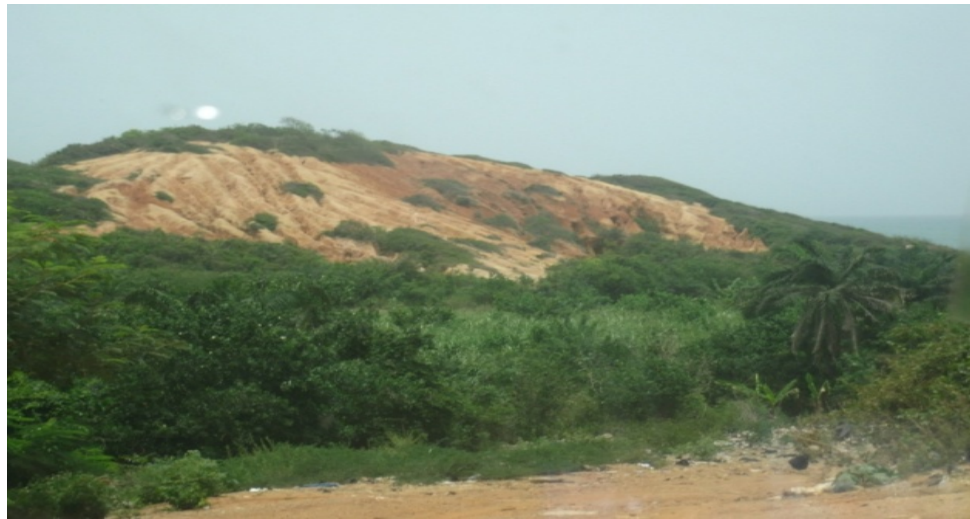
Plate 11: Residues of laterite cappings which were formed under sub-aerial conditions. These residual are regarded as erosion surfaces (*coastal* surfaces) believed to be the coastal extensions of the *Akumadan* surface (Dei, 1972; Field Observation, 2008-2011).

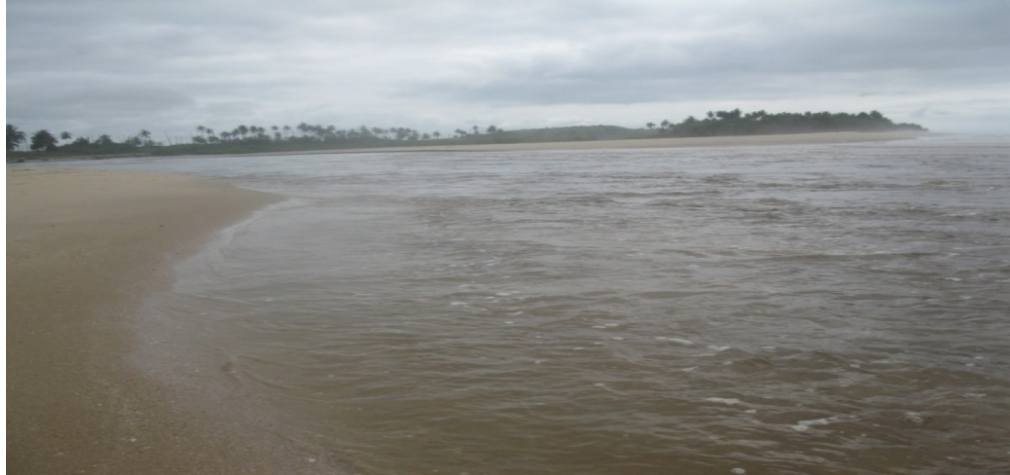
Plate12: The Amissano estuary (Field Observation, 2008-2010).

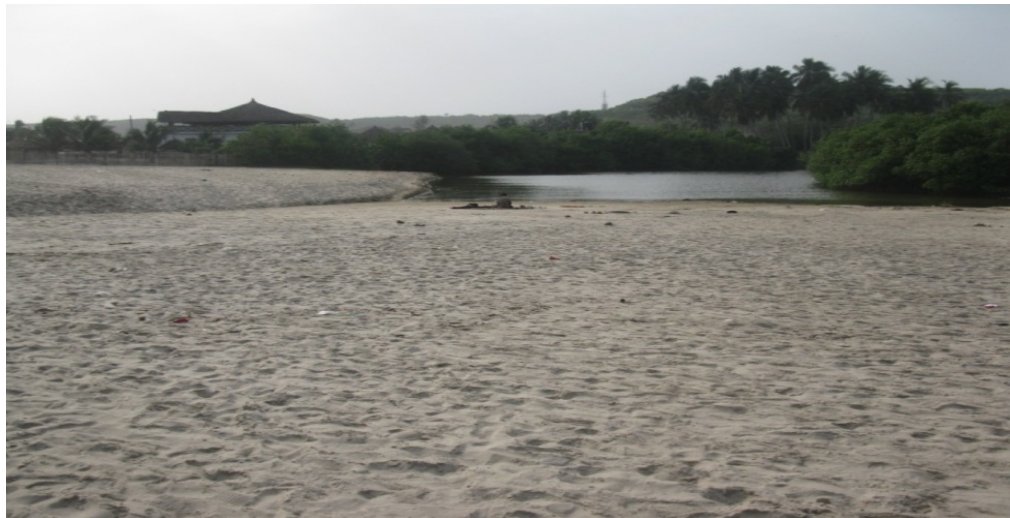
Plate 13: showing the Etsii lagoon at Abandze. The accumulated sand at the outlet of the lagoon has been removed at the time the image was taken and it was being rebuilt by the sea with beach sand. Observe how the other side of the outlet close to the resort centre was left high above the ground unexcavated (Field Observation, 2008-2010).

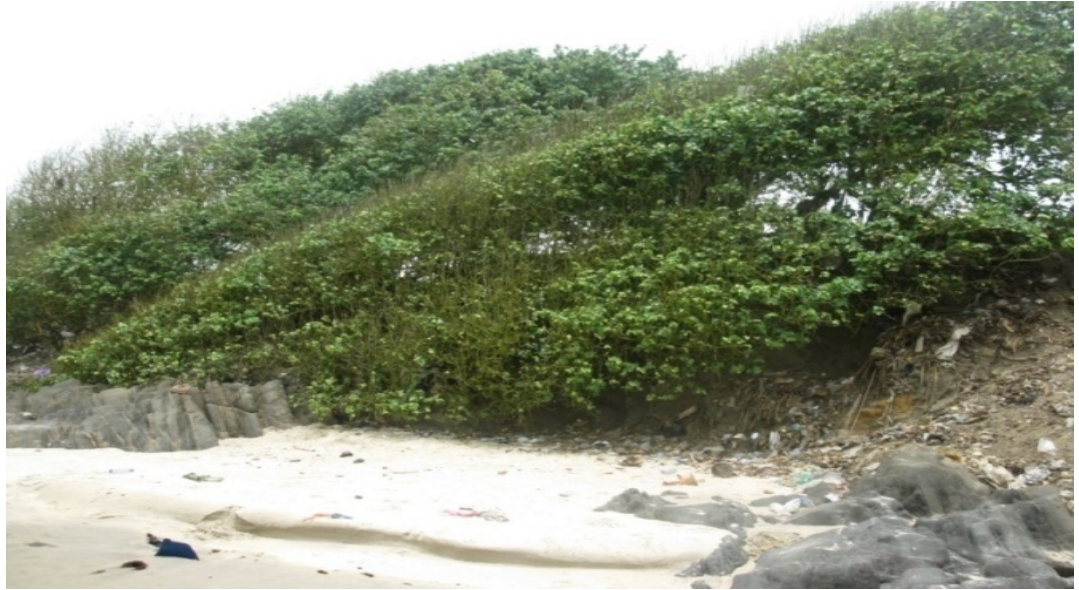
Plate 14: A Picture of mangrove vegetation in the study area. Note how the strength of the wind has casted the vegetation into a west- east (west-north east) direction. The west-east direction of the wind and the increased fetch distance eastwards have all contributed to the increased erosive activity eastwards, hence a reduction in sand grains and pebbles eastwards. (Field Observation, 2008-2011).

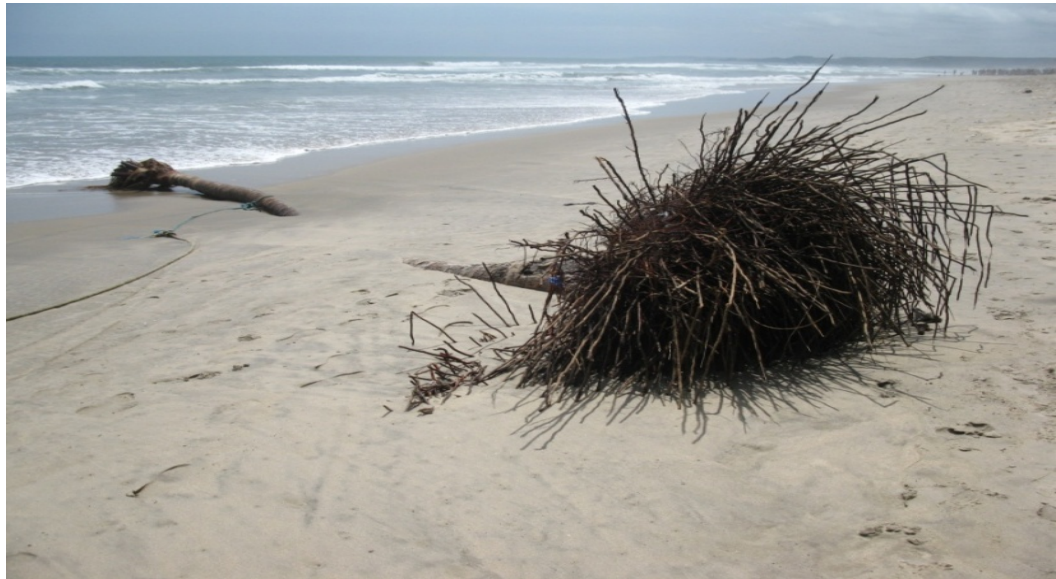
Plate 21: An uprooted coconut tree by the advancing sea on the beach near Kormantse. The natives tie fallen coconut trees to standing ones backbeach to prevent it from being carried away by the sea during high tides

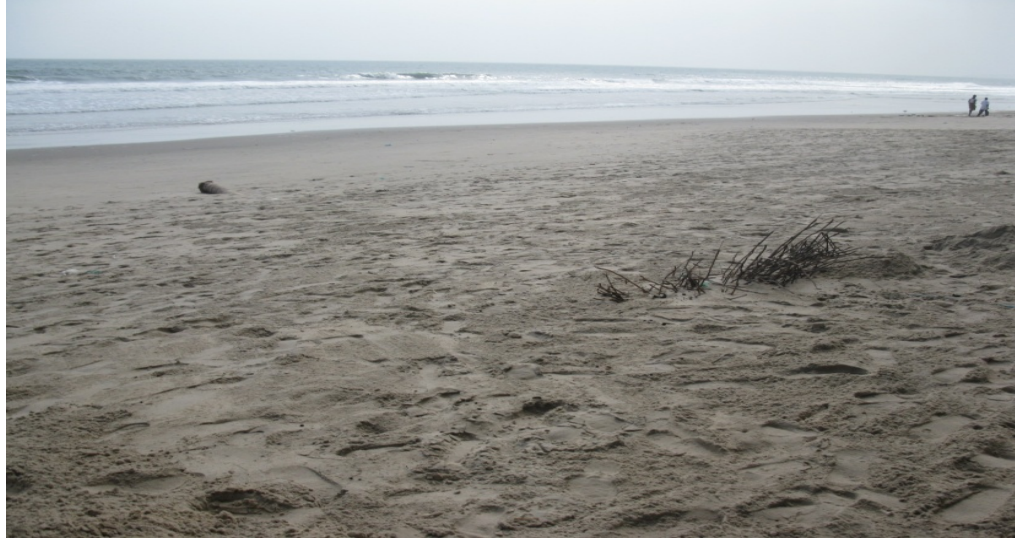
Plate 22: Three weeks after observation, the above coconut tree was buried deep in the beach sand following accumulation during low tide.

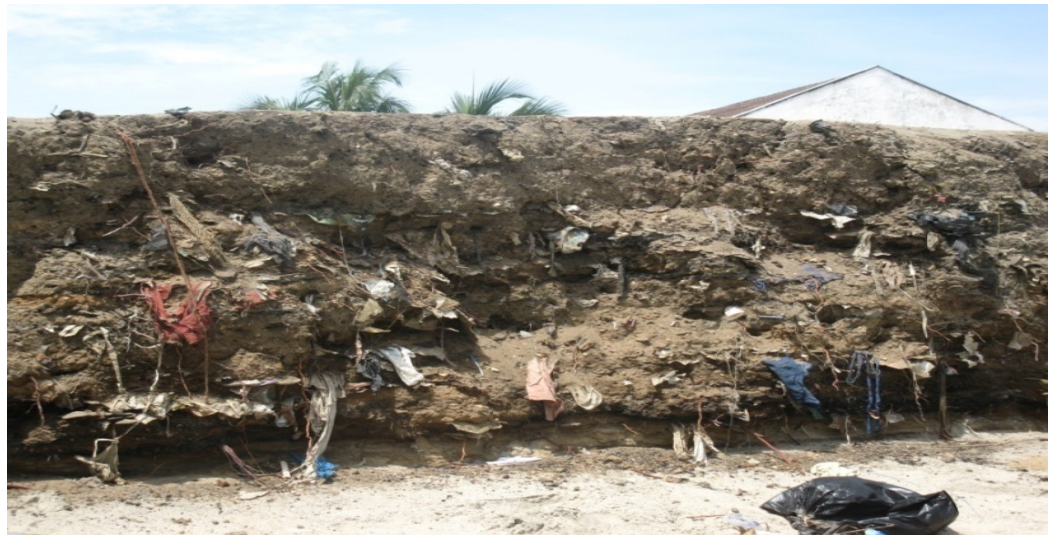
Plate 23: A retreating refuse cliff in zone C.
