Abstract

33 **Keywords:** Coastal erosion management; shoreline change monitoring; GIS; beach sand
34 mining; Ghana

101 Information System (GIS) tools to identify coastline changes that has occurred in the Elmina,
102 Cape Coast and Moree area from 1974 to 2012. Major coastal erosion contributing factors in
103 this area are also identified.

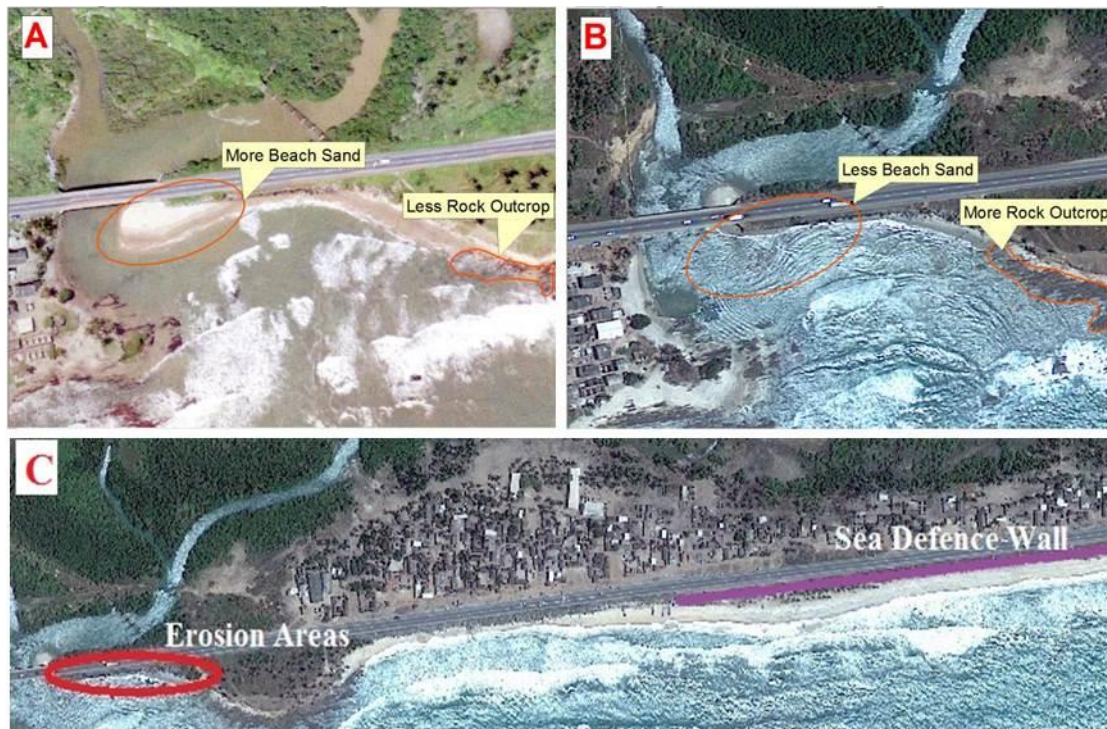
374 Figure 11: Erosion of sandy beach at the Elmina Highway Bridge. (A) shows more sand at
 375 the Elmina Bridge in 2005 which was eroded by 2011, (B) with further exposure of
 376 underlying rocks, (C) shows section of the 1.5 km rock revetment sea defence near the
 377 Elmina Highway Bridge.

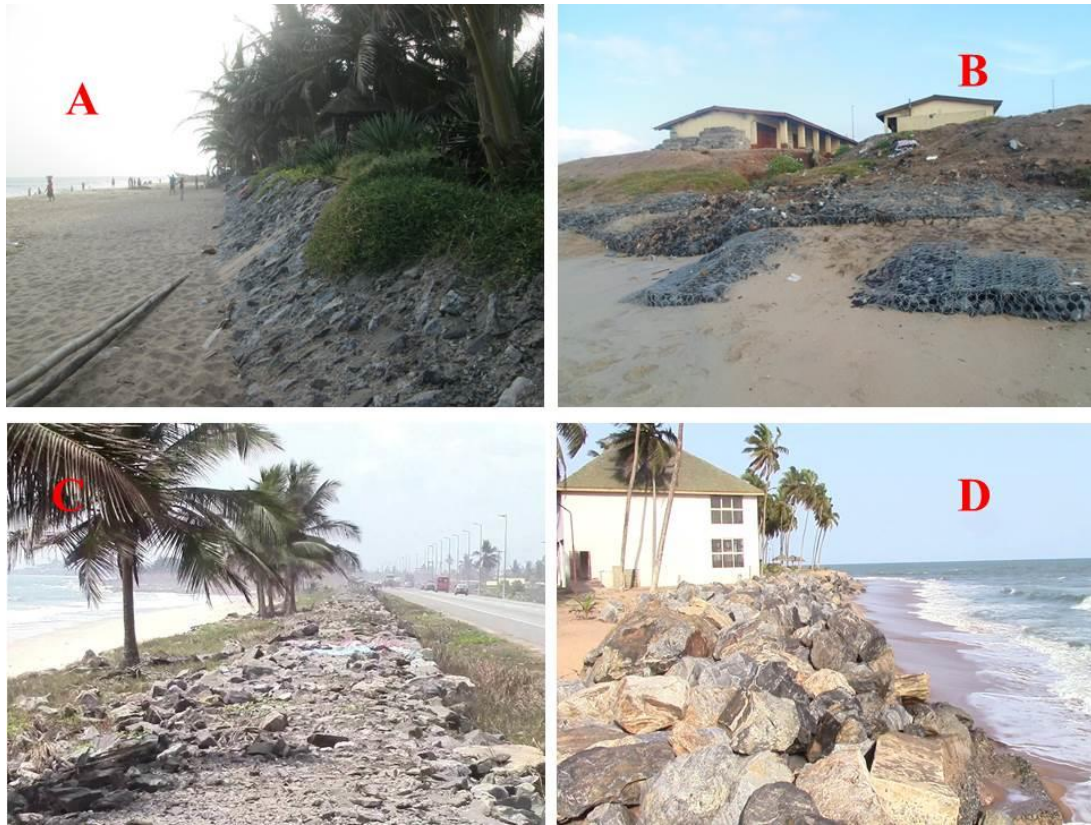
408 Figure 12: Some coastal defence structures in the study area. (A) Seawall to protect a beach
 409 resort in Cape Coast, (B) wire mesh revetment to control erosion near a school facility in
 410 Cape Coast, (C) section of a 1.5 km major sea defence project to protect a section of the Cape
 411 Coast-Takoradi highway, (D) boulder revetment used to prevent further destruction to a
 412 beach resort at a rapidly receding beach in Elmina.

399 Several signs of coastal erosion are evident in the Elmina, Cape Coast and Moree area,
400 including beach scarps and underlying hard rock exposures. As suggested by Leatherman et
401 al. (2003), sea level rise and shoreline recession on one side and increasing human
402 development and migration on the landward side, leading to a collision. In recent years,
403 tourism facilities within the Elmina, Cape Coast and Moree area have been constructed closer
404 to the coastline than before. In several instances, the response of property owners to erosion
405 has been to armor their section of coastline (Figure 12A, D); in the long run the problem is
406 either exacerbated or transferred onto to adjacent sections.
