A national survey of MRI safety practices in Ghana

Cite as: Albert Dayor Piersson, Philip Nii Gorleku. A national survey of MRI safety practices in Ghana.

Heliyon 3 (2017) e00480.
doi: [10.1016/j.heliyon.2017.e00480](https://doi.org/10.1016/j.heliyon.2017.e00480)

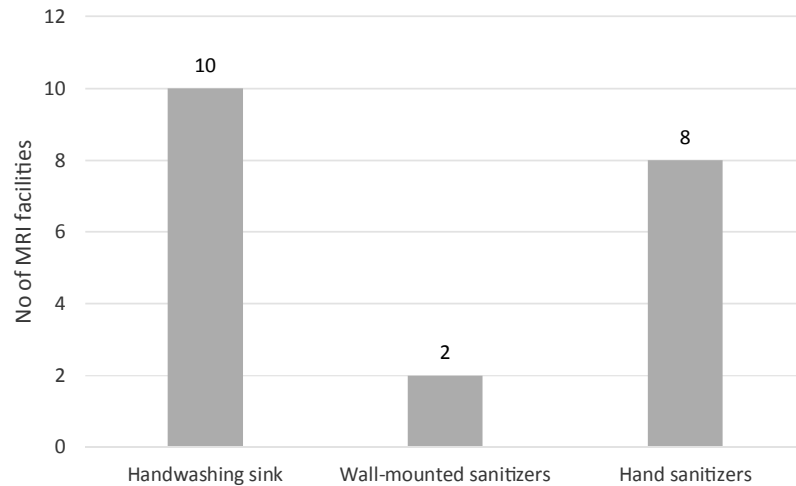
Fig. 4. Summary of Infection control practices.

The availability of hand washing sink and hand sanitizers in most facilities (Fig. 4) as indicated by the respondents is laudable. To demonstrate the importance of hand washing, the ACR [5] recommended that infection control policy be instituted in the clinical practice of MRI with consideration for hand washing stations. This is to prevent cross-infection among staff who come into direct contact with patients.
